DEPARTMENT OF DEFENCE
DEFENCE SCIENCE AND TECHNOLOGY ORGANIZATION
AERONAUTICAL RESEARCH LABORATORIES
MELBOURNE VICTORIA

Structures Note 424

**THE PERFORMANCE OF AIRCRAFT
CONTROL CABLES
UNDER SERVICE CONDITIONS**

APRIL 1976

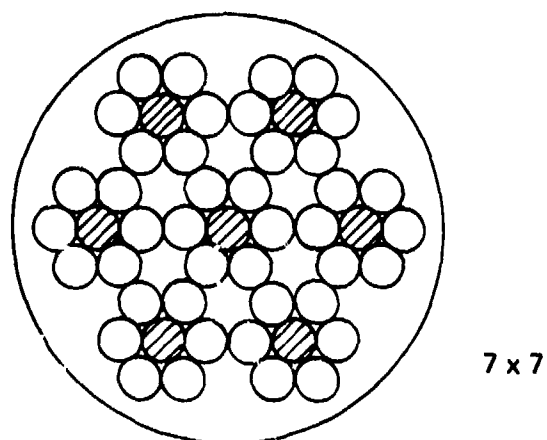
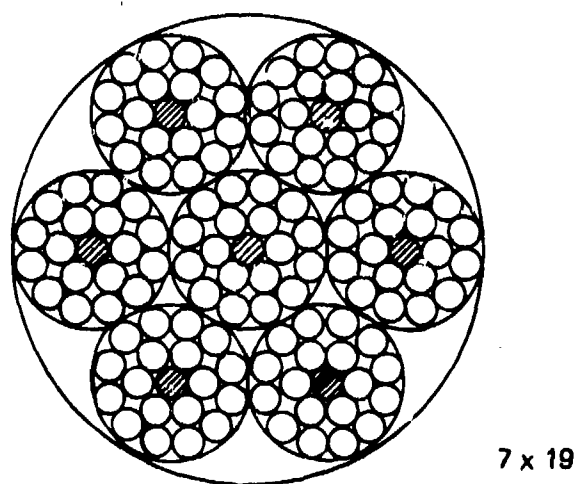
ARRANGEMENT OF WIRES IN 7 X 7 CABLE AND 7 X 19 CABLE

The layout of the wires in the cables is illustrated in Figs. 1 and 2.

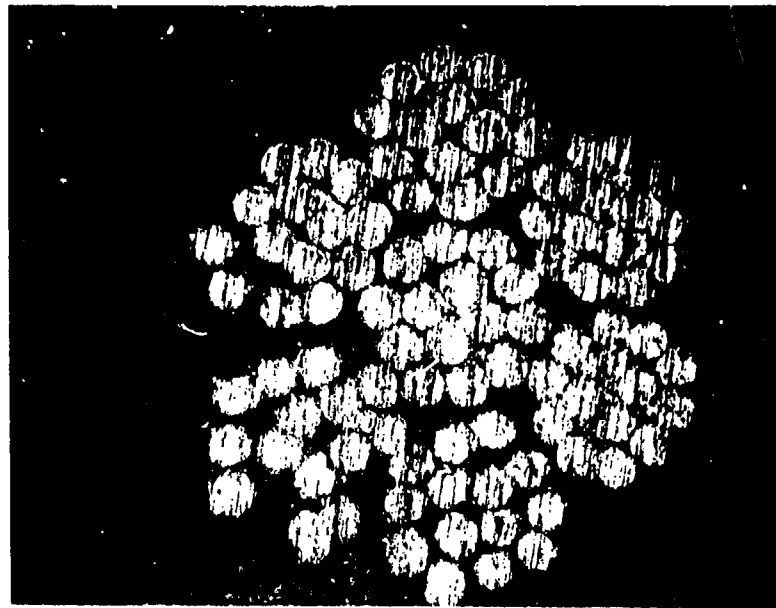
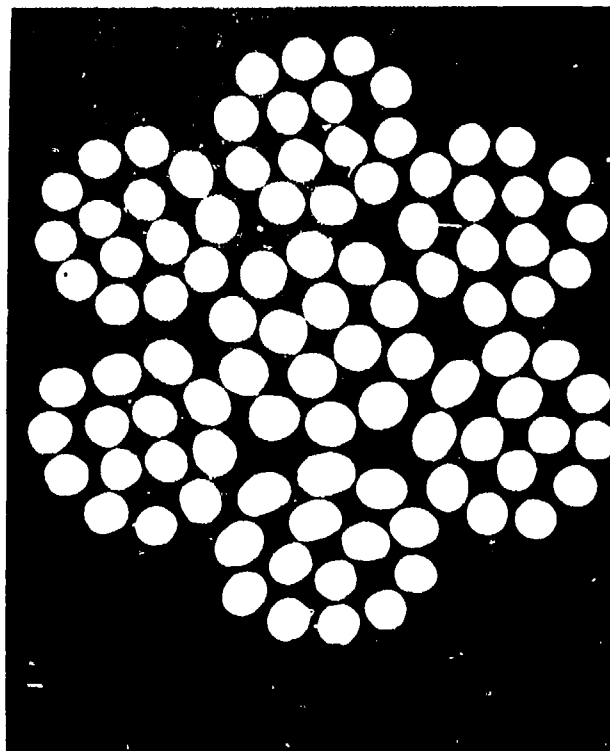
(a) As cut at one end

(b) Polished at the other end

ARRANGEMENT OF WIRES IN A 498 kN (10 CWT) 7 x 14 CABLE TO BSW 9
(Set in araldite)

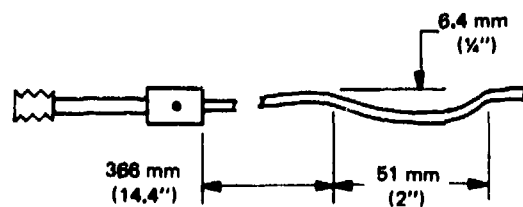
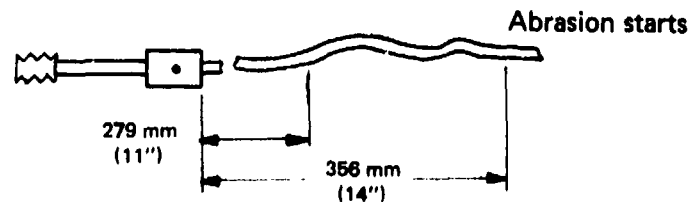
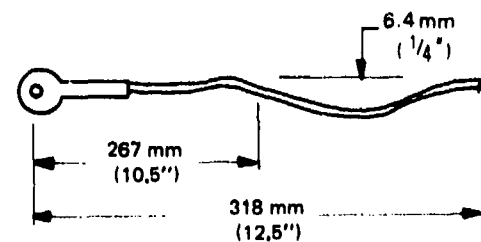
Cable deformations

Stbd cable
Horn . attachment end

Cable JA 2393X
Port cable
Horn . attachment end

Port cable
Rudder pedal attachment end

CABLES ON VHD

In the Auster rudder cables most of the worn and distorted sections of cable occurred at 254-305mm (10 - 12 inches) from the rudder pedal eye attachment and 356mm (14 inches) from the horn turnbuckle attachment (Fig. 3). The wear for the former condition was at a change of direction pulley and the latter where the cable rubbed on the fabric fairlead or emerged from the rear fuselage. It was at this latter location where some of the cables were corroded and the position where VHC had severe internal corrosion which was not detected by external visual inspection.

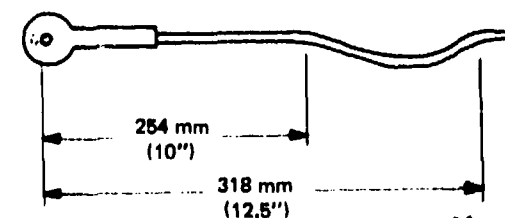
Max. abrasion measured 0.05 mm (0.002'') on dia.

CABLES FROM VHC.

The 7 x 7 cable from VHC had worn approximately 0.051 mm (0.002 inch) where it had rubbed on the fabric but had no other abnormal change in appearance. However, extremely close inspection revealed a slight discolouration at the point of the strands. Cutting of the cable and subsequent inspection with a microscope showed that a considerable area of the strand in contact with the core strand had corroded and brinelling of the wires of adjacent strands had also occurred. This damage was attributed to the continual hammering and rubbing between the wires of the cable under fluctuating tension arising from cable vibration due to rudder buffeting from the propeller slipstream. However, the same state of corrosion and brinelling was found in a 7 x 14 cable removed from a glider where vibration could occur due to self excitation or running over uneven ground surfaces. It was interesting to note that this glider cable, while showing outer wear of approx. 0.051 mm (0.002 inch) had several core strand wires failed as shown in Fig. 7. In another glider cable wires in several strands had failed in fatigue at various locations but little or no wear was externally evident (Fig. 8). It was only after several inspections of the cable that these wires were observed because the fractures were of such a nature that the "cloth method" of detection (Ref. 6) did not indicate any failed wires.

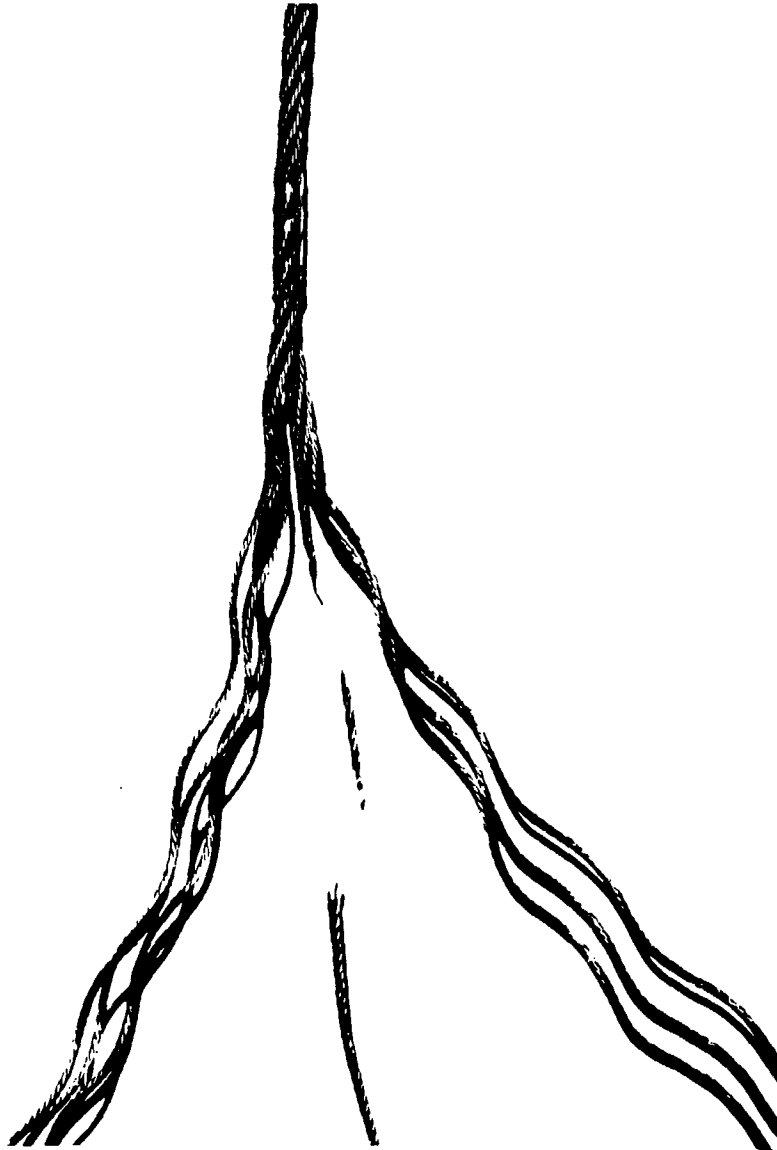
Neg. no. 5409

INTERNAL WIRE DAMAGE IN CORE STRAND VHE

The difficulty of detecting internal wire damage was emphasised when the operator of VHE removed both 7 x 14 rudder cables two flying hours after a Certificate of Airworthiness because of a broken wire found in one of the cables. These cables were examined in the laboratory and one was found to have a completely broken core strand, each side of the fracture was corroded a distance of about 12.7 mm ($\frac{1}{2}$ inch) and indications were that failure had existed for some time prior to the inspection.

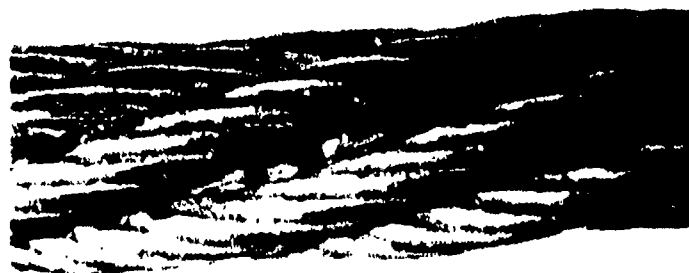
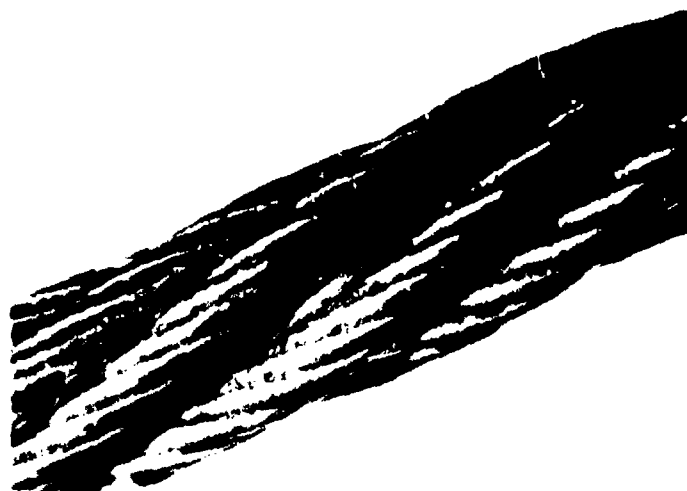
Worn and fretted cable 7 x 14
removed two flying hours after a C. of A. inspection

FIG. 8 (VISIBLE DAMAGED WIRES PRIOR TO UNRAVELLING)

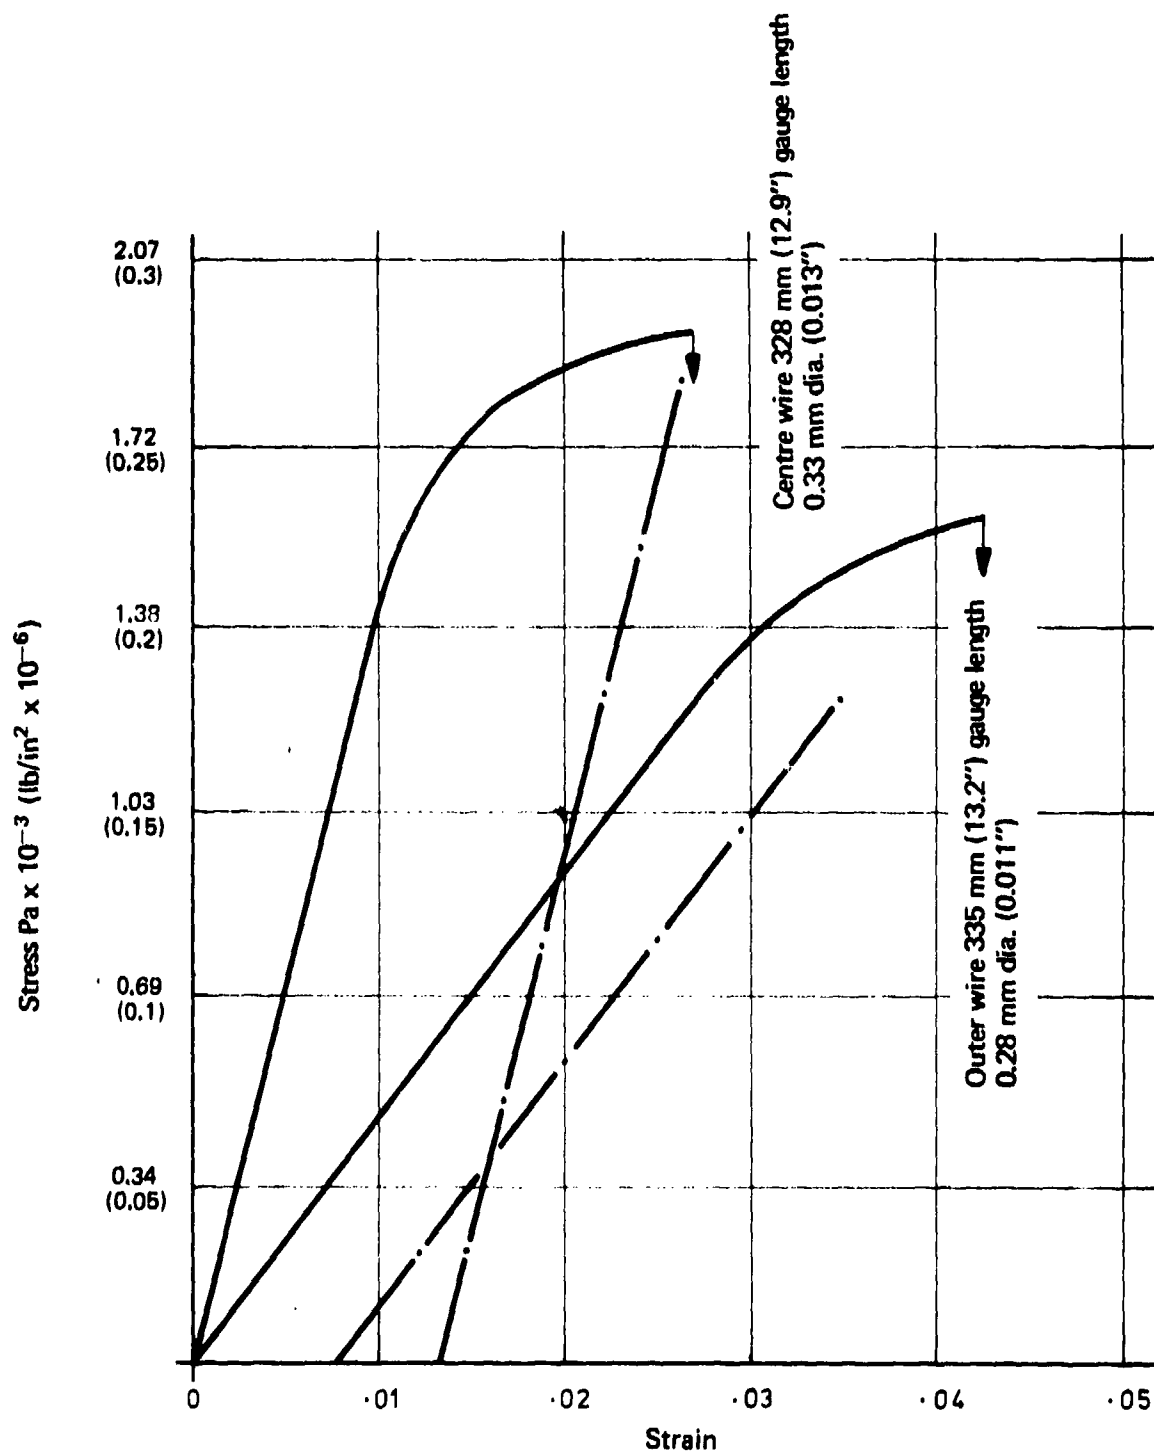
STRESS-STRAIN CURVES FOR TWO WIRES OF A 10 CWT (498 kN)
7 X 7 GALVANIZED CABLE.

However, these graphs give the average tensile stress and an indication of the plastic elongation at failure. It is interesting to note that both the ultimate stress and the plastic deformation of the outer wire appear to be significantly less than the centre wire. It is possible that this effect is due to the superimposed bending stresses applied in straightening the preformed outer wire. In such very hard drawn wires these stresses are likely to be quite significant.

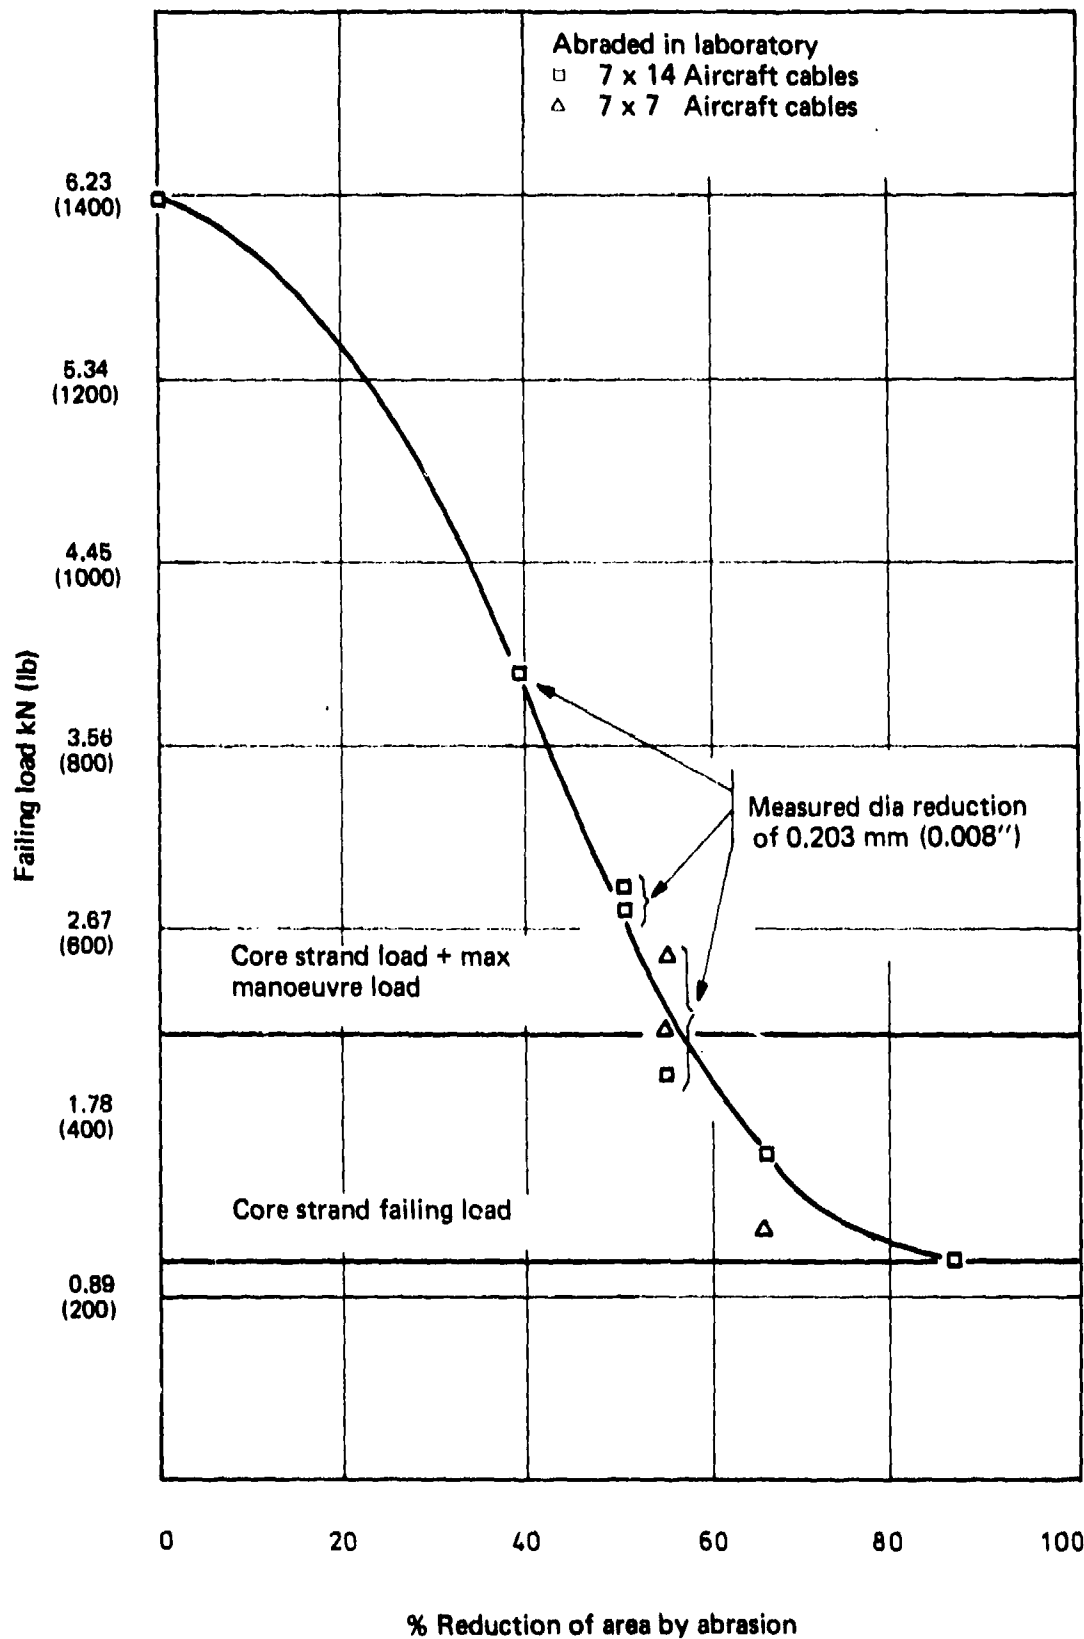
VARIATION OF FAILING LOAD WITH REDUCTION IN AREA OF CABLE.

(Extracted from ref.1)

By microscopical examination of each cable tested the area of the failed section of each wire was measured to within an estimated 5%. This enabled the failing load to be plotted against percentage reduction of area in Fig. 10, and against reduction of cable diameter in Fig. 11. There is a considerable variation in results but curves have been drawn through average values. The percentage reduction of area was estimated by the microscopic examination of abraded cables that had failed in service and an estimate of the expected failing load could be obtained from Fig. 10.

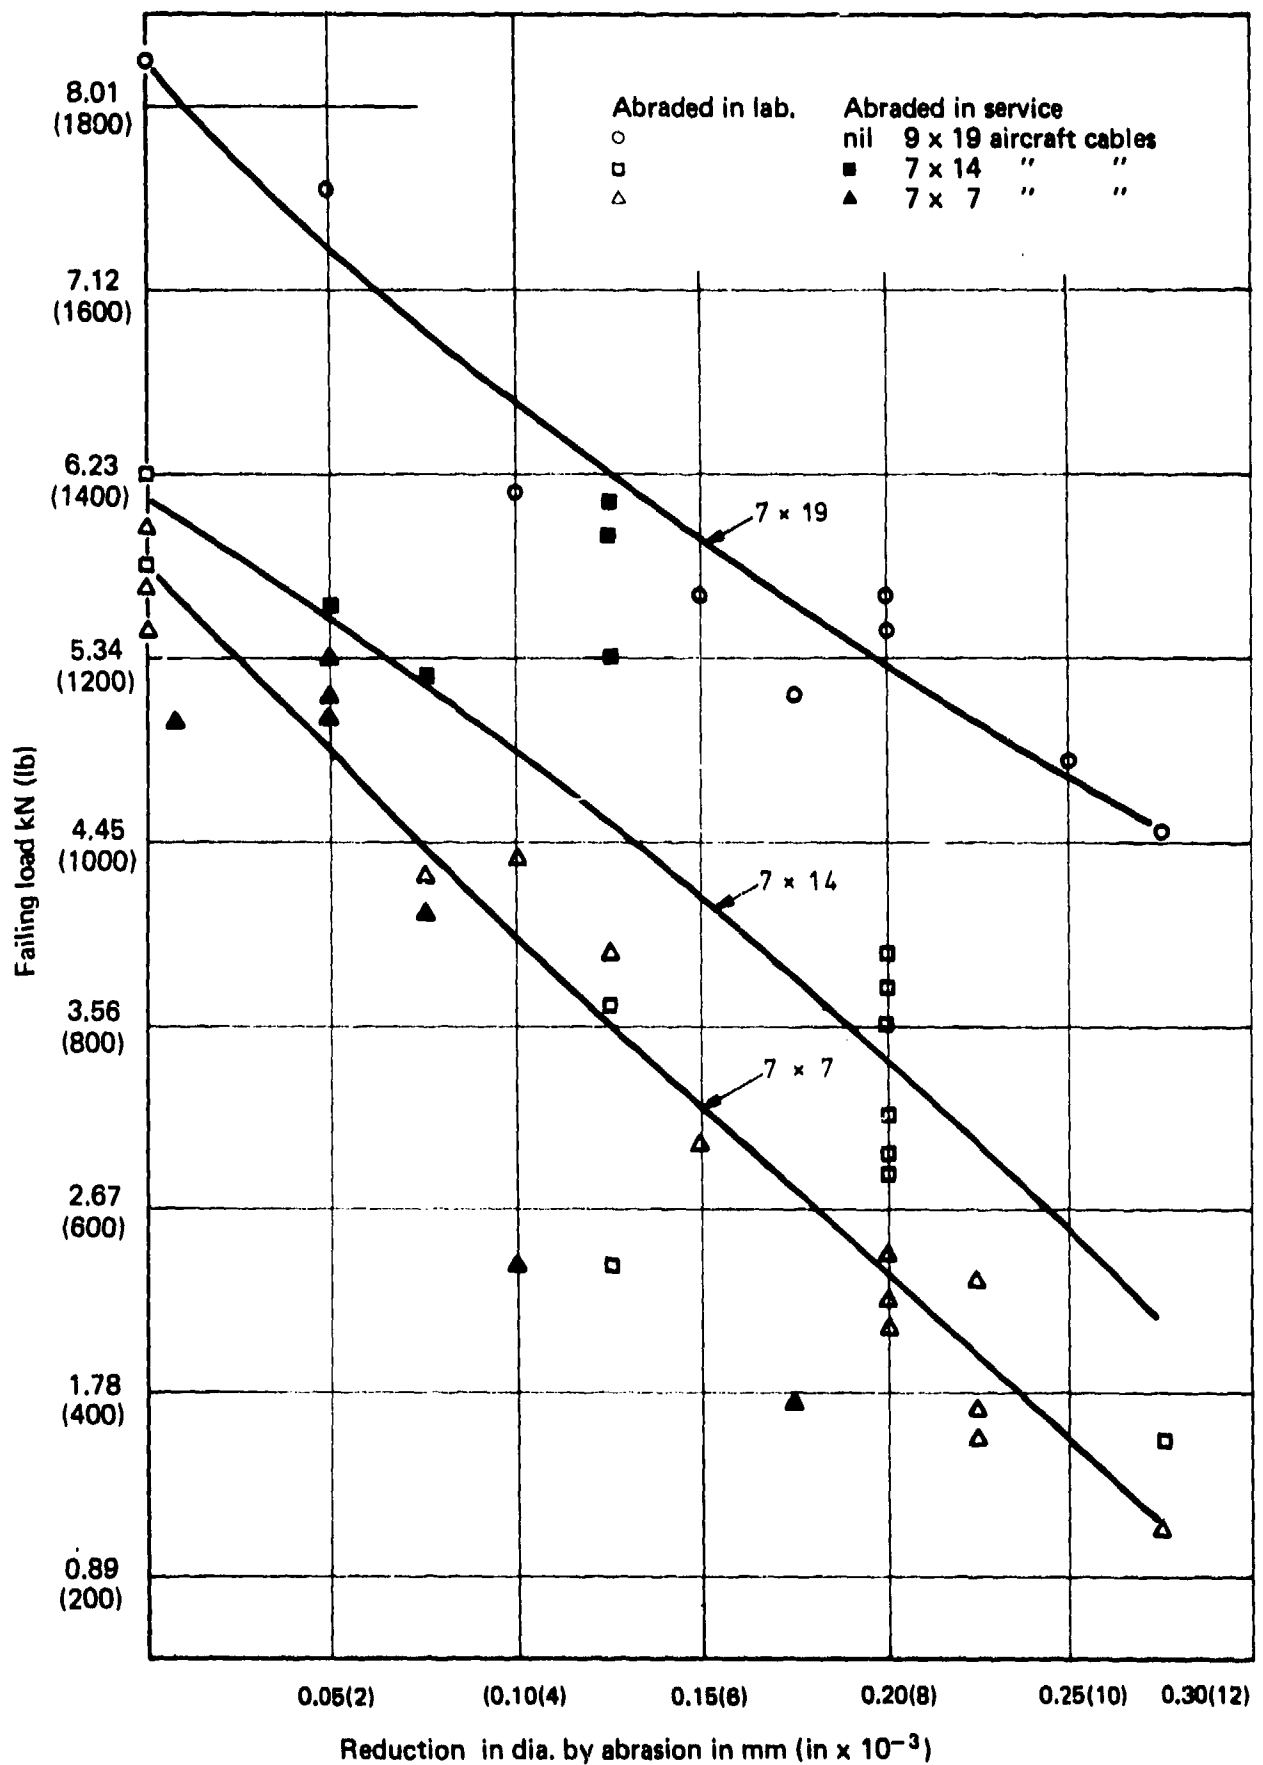
FAILING LOAD OF ABRAIDED CABLES (Extracted from ref. 1.)

To investigate the effect of wear in service, the minimum diameter of the worn cables taken from service was measured and the failing load determined in a tension test. New cables were also abraded using fine emery cloth and rubbing the cable by hand in a longitudinal direction over a length of three inches and around one third of the circumference. This corresponded to the extent of the worn area observed on cables from service. The failing load of the cable was then determined in a testing machine, the overall length of the cable being 610 mm (24 inches).

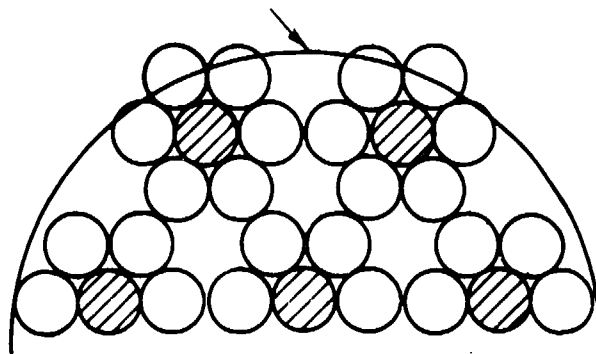
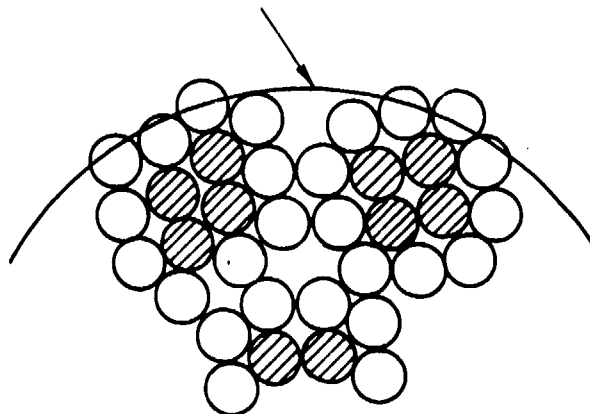
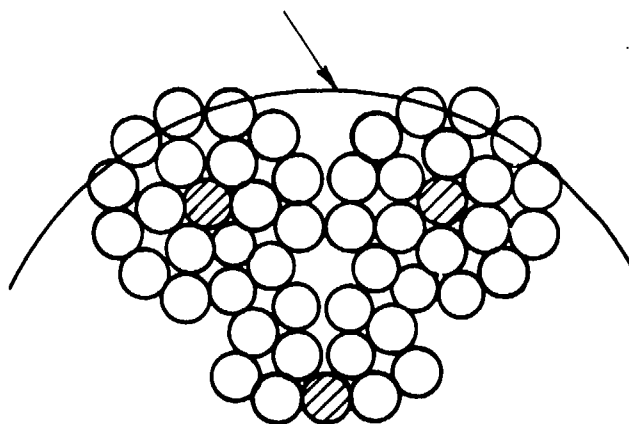
0.15 mm (0.006") wear line

7 x 7

wire dia. 0.28 mm (0.011")
cable dia. 2.59 mm (0.102")

7 x 14

wire dia. 0.23 mm (0.009")
cable dia. 2.90 mm (0.114")

7 x 19

wire dia. 0.20 mm (0.008")
cable dia. 3.35 mm (0.132")

WEAR ON INDIVIDUAL WIRES OF VARIOUS CABLES.

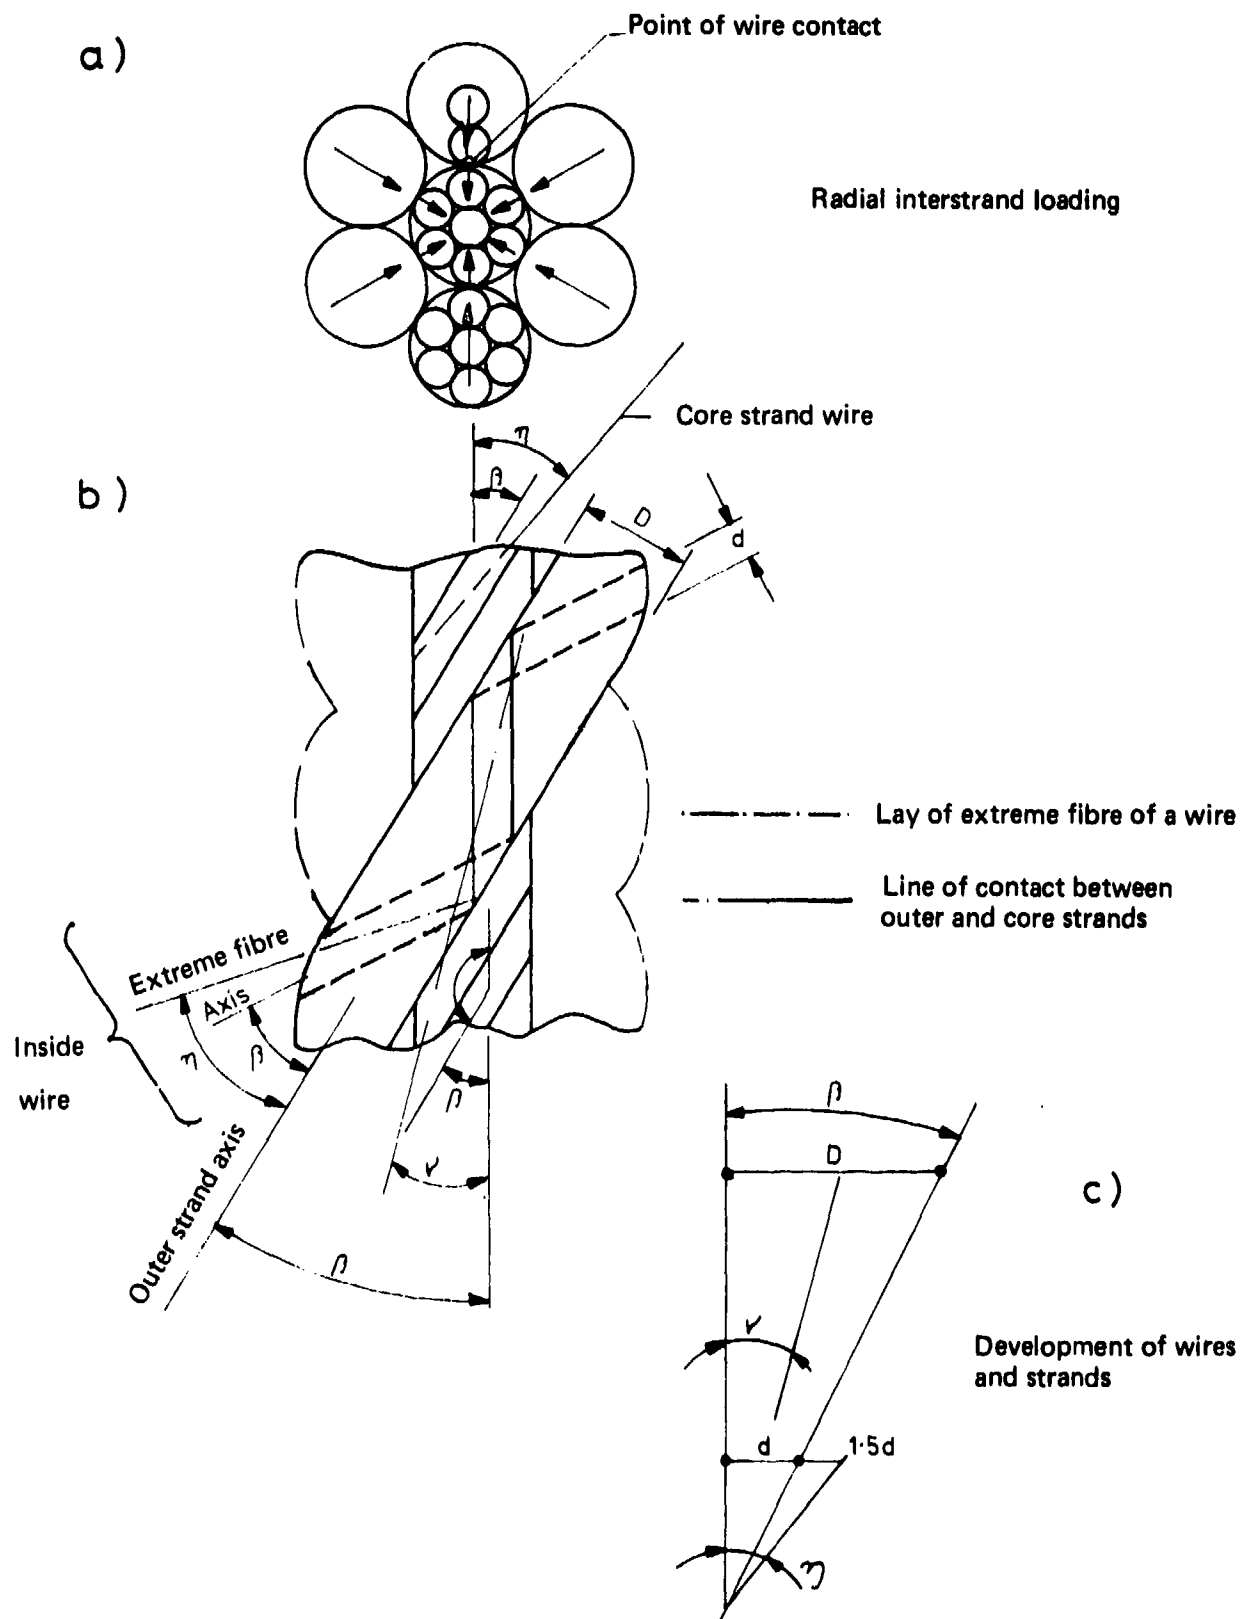
GEOMETRY OF 7 X 7 CABLE.

Some of the wires of the core strand under contact from the wires of the outer strands showed evidence of plastic deformation. Evidence of fretting was also present. In the tests to failure on new cables described in Para. 3.1 there was also evidence of the wires in the core strand having been indented by wires from the outer strands. In a cable the outer strands are arranged in a helix around the core strand. When tension is applied to the cable the outer strands close on the core strand resulting in pressure between adjacent strands in the rope. In a similar way contact forces occur between wires within the core strand. Forces at contact between strands also arise due to the cable passing around a pulley, the most heavily loaded strand being the inner strand bearing against the pulley.
